Lufttüchtigkeitsanweisung
LTA-Nr.: DULV-2014-001
Datum der Bekanntgabe: 13.06.2014

Luftsportgeräte-Muster:
ELA 07 Cougar; ELA 07 S

ELA AVIACIÓN, S.L.
SERVICE BULLETIN Nº 16.

Maintenance procedure and lifetime of hub bar P/Nº: 14-145B

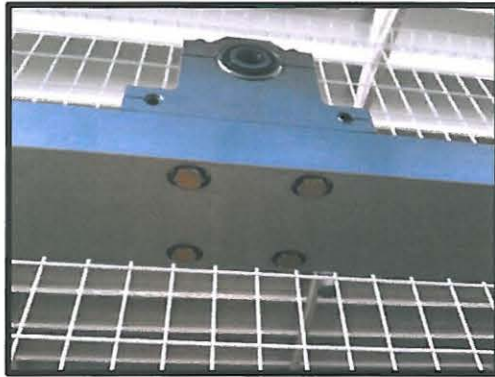
Old hub bar P/N: 14-145B.

In the case of non-proper use, storage, inspection and maintenance of the gyro, there is an area in the hub bar where some cracks can appear during operation.

This area is located in the lower face of the hub bar, where the bolts heads are inserted in a machined groove.

The lifetime of the hub bar is limited to 500 flight hours, and then it should be replaced by the new hub bar P/Nº: 14-145C.

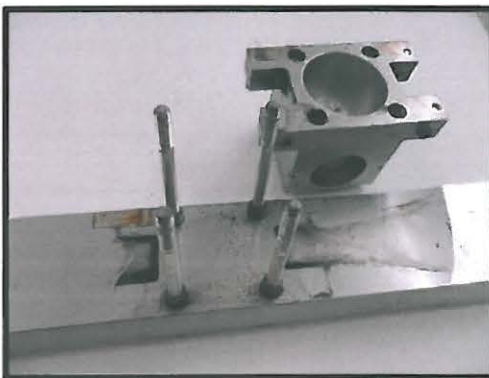
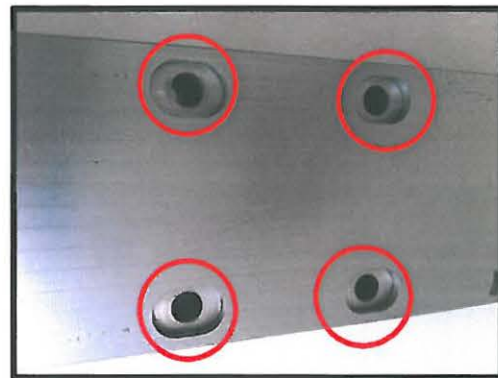
3) Clean the parts and inspect the bore holes to confirm the absence of cracks in the hub bar and block. Perform a dye penetrant inspection test on this area of the hub bar by a qualified inspector.

4) Re-assemble the block with new bolts and nuts in the same position.
