**Lufttüchtigkeitsanweisung (LTA)
Nr. 2024-001**

Prime BS100

Service Bulletin No.	BPU-SB-2024-02
Rev.	1
Date Issued	03/05/2024
ATA Code	5
Page	1 of 7

Title: Measures for preventing Fuel Tank overpressure

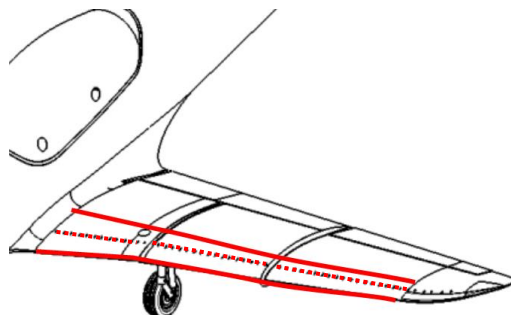
1. Perform visual inspection on the external surface of LH and RH wings, checking along the bonding lines of the wing skin to the forward spar and on the leading edge of the wing, in correspondence of the bonding line between upper and lower skins, for presence of deformations, cracks, or any other signs of damages of the external surface. See Figure 1 for the identification of the bonding lines.

Figure 1 – Bonding lines (the dotted line refers to the bonding line of the lower skin to the forward spar)

2. In case of deformations, cracks, or any other signs of damages of the external surface, stop any flying activity and contact aftersales:
aftersales@blackshapeaircraft.com

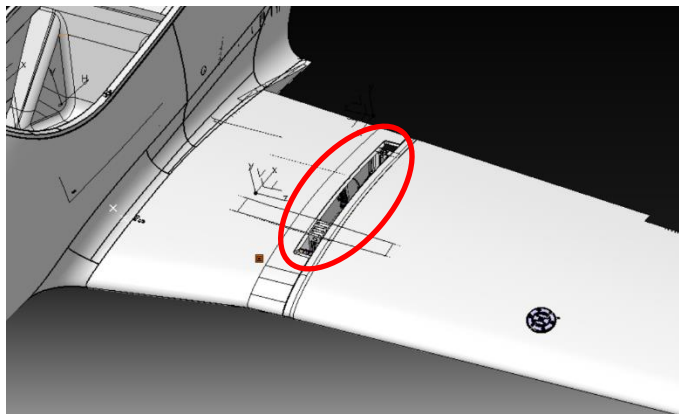
Figure 2 – Wing inspection door.

1. Remove wing inspection door highlighted in Figure 2

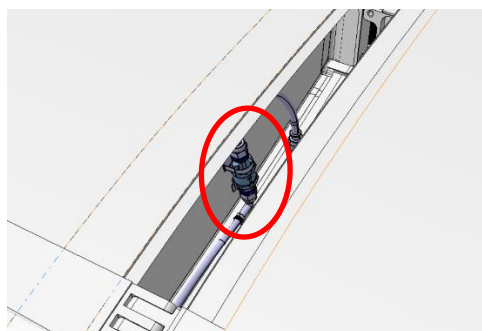
Figure 3 – Rollover valve position in wing inspection door.

2. Uninstall the rollover valve seated in the wing inspection door (see Figure 3) by unscrewing the 90° fittings [1] see Figure 4

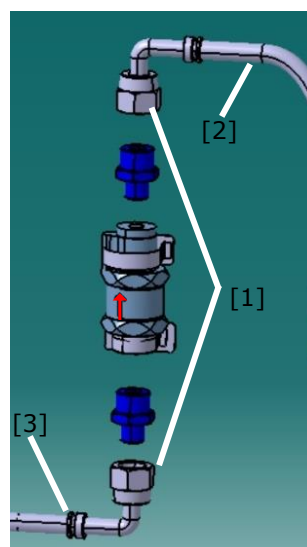
Figure 4 – Rollover valve installation.

3. Verify that the rollover valve and adjacent venting circuit components are free from obstruction by blowing air (do not use compressed air) through the following components:

- a. the rollover valve in both flow directions keeping the valve in the vertical orientation with the arrow (see Figure 4) pointing upwards and then pointing downwards.
- b. the tube from the rollover valve to the vent port ([2] in Figure 4) checking that the air goes out through the vent port.
- c. the tube from the rollover valve to the fuel tank ([3] in Figure 4) checking that the air goes out through the fuel filler cap hole.

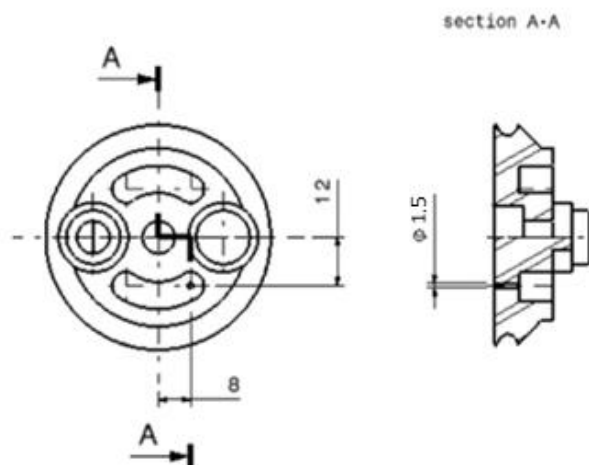
Figure 5 – Fuel filler cap small opening.

1. Send both fuel filler caps to Blackshape ⁽¹⁾ for reworking.

The reworking performed by Blackshape consists in making a small opening of 1.5mm onto the fuel filler cap as specified in Figure 5.

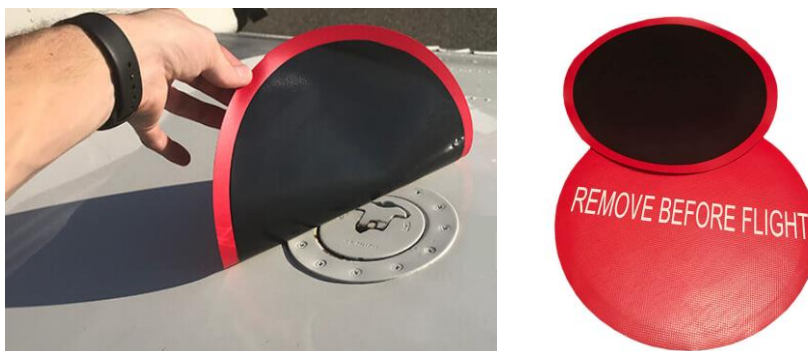
Figure 6 - Fuel Cap covers.

Install a fuel cap cover on top of the fuel cap (Figure 6). The fuel cap covers are necessary to avoid contamination of the fuel tank from the fuel cap small opening. They must be used whenever the aircraft is on ground.

- **Fuel Limitations:**
Individual tank max fuel quantity: 30 L
- **Approved manoeuvres:**
Avoid uncoordinated flight (slip ball out maneuver)
- **PRE-FLIGHT**
Remove fuel cap covers as per Figure 6
- **POST-FLIGHT**
Install fuel cap covers.
