<b>SERVICE BULLETIN</b>	25-04-2025
		No. 01-2025

This service bulletin applies to all Aviation Artur Trendak gyrocopters with engines with an AAT injection system.

Crankshaft position sensor replacement.

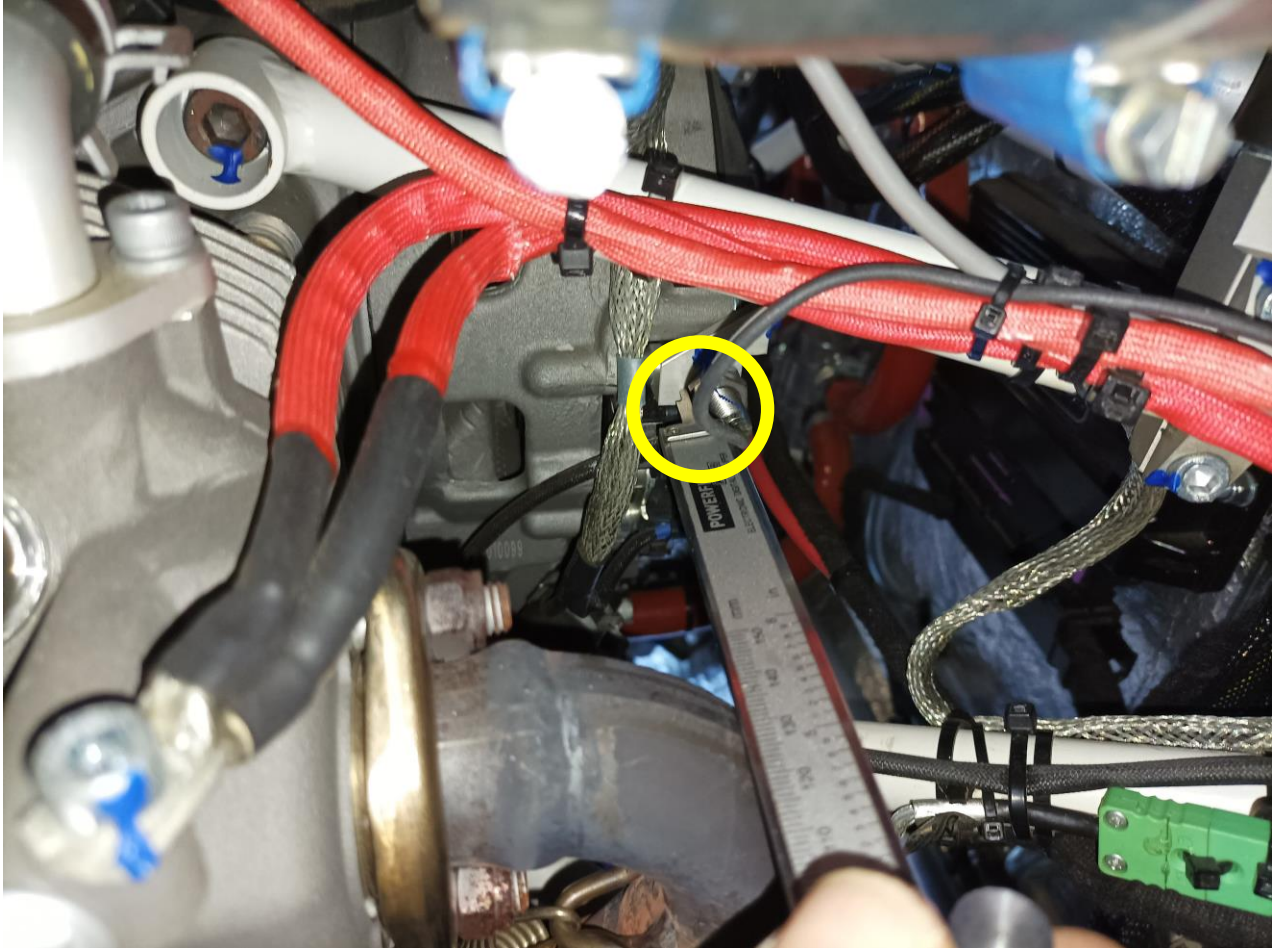
Figure 4. Crankshaft position sensor measurement.

- 2) A result above 21mm indicates the use of a new type of sensor. Do not replace it with a new one.

A measurement result below 15mm indicates the use of a faulty type of sensor. Replace this sensor with a new one.

- 1) Measure the length of the installed sensor using a caliper as shown in Figure 4. It is important that the measurement is taken from the sensor holder to the end where the cable exits.

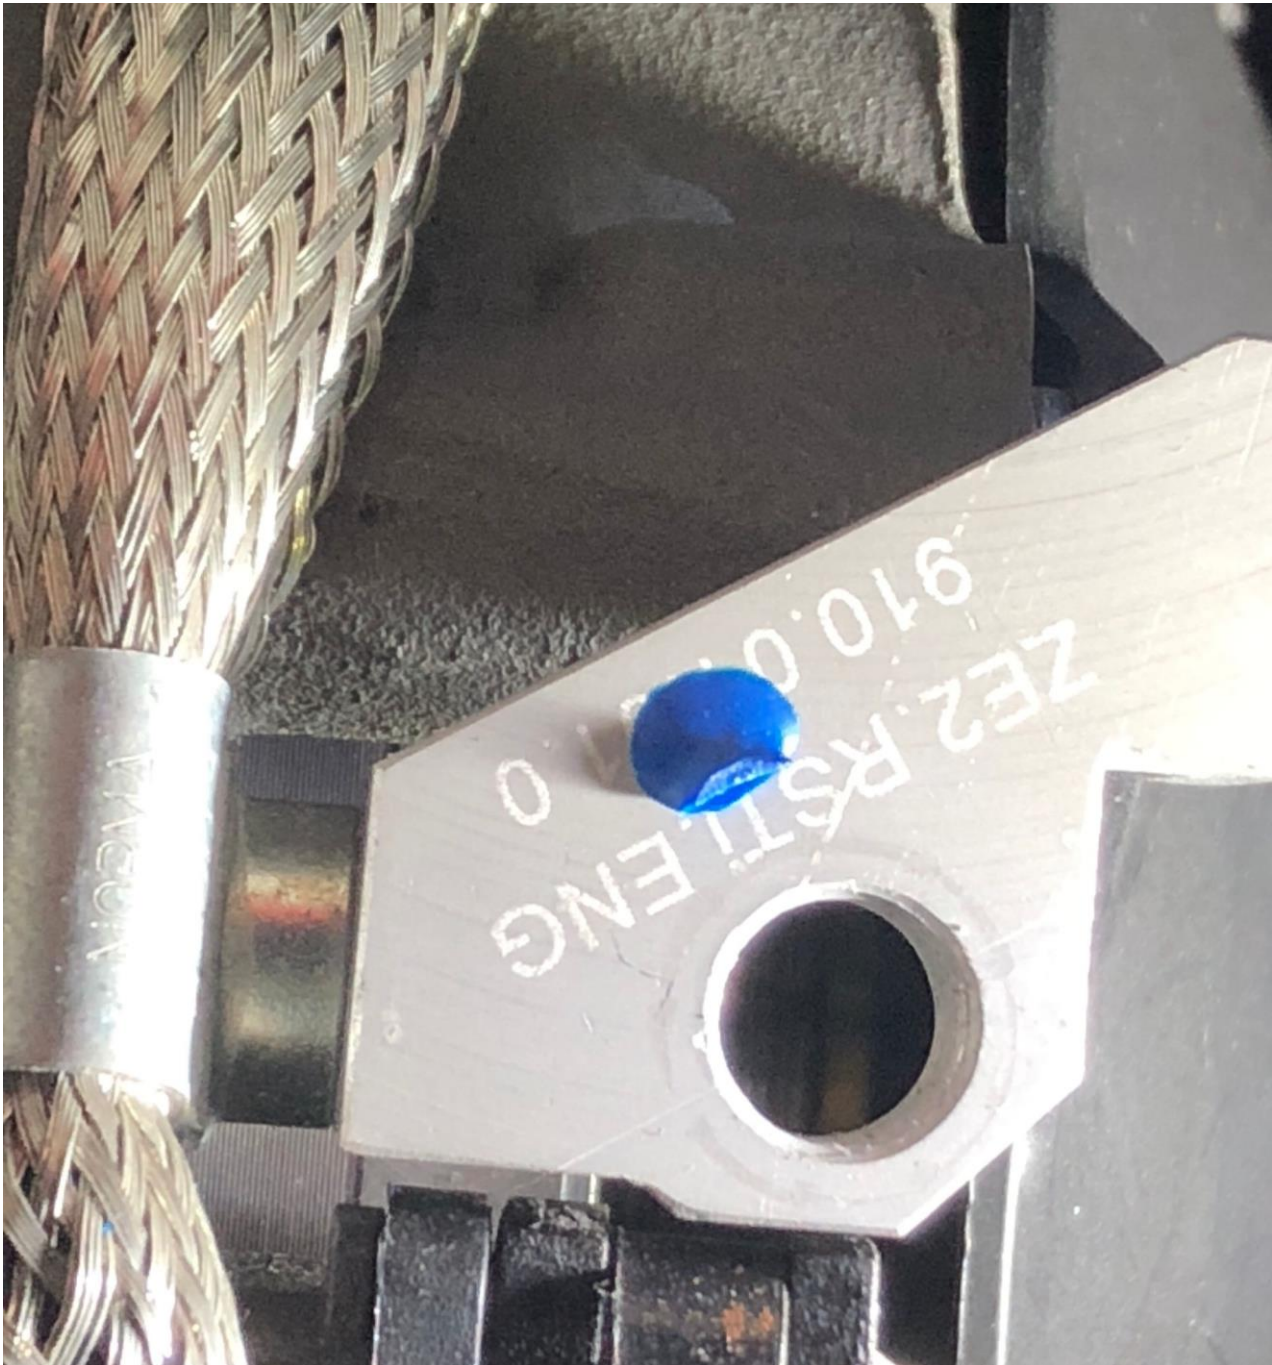
Figure 7. Incorrect position of the magnet wheel.

Figure 7. Shows the incorrect position of the magnetic wheel.
