Company name: Pipistrel Vertical Solutions d.o.o.

SB Name: Wing surface inspection**Category:** Information / Recommended / Mandatory**Subject:** Visual Inspection of wing surface.**Affected Aircraft:** All fuel driven Pipistrel aircraft with integrated wing fuel tanks;
-Sinus, Sinus NW, Virus, Virus SW, Virus SW 127, Virus SW 600 D,
Taurus, Apis: All Serial numbers**Date of issue:** 23.12.2021**Date of effect:** 23.12.2021**Time of Compliance:** By 28.02.2022**Reason:** Attributed to different quality of fuels, damage has been reported on some aircraft with integrated fuel tanks.**Actions: Part 1: Visual inspection of affected wing areas**

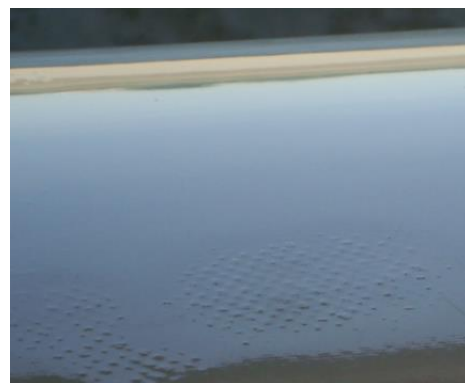
Figure 1

Possible anomalies: uneven surface, dents, swelling of paint and/or laminate, blisters.
