SB Issuer

Company name:	Pipistrel Vertical Solutions d.o.o.
Address:	Vipavska cesta 2, 5270 Ajdovščina, Slovenia
Website:	www.pipistrel-aircraft.com
Types:	Taurus
Model:	Taurus 503, Taurus Electro G2, Taurus Electro 135

SB name: Welding inspection on control stick connection rod**Category:** Information / Recommended / Alert-SB- / Mandatory**Subject:** Instructions for the inspection of the weld on the control stick connection rod.**Affected aircraft:** All TAURUS M, TAURUS Electro G2.5 and TAURUS Electro aircraft registered as UL, S-LSA or Experimental, with date of manufacture prior to release of this document.**Date of issue:** 29 August 2025**Date of effect:** 29 August 2025**Time of compliance:** Before the next flight**Date of corrective action:** N/A**Reason:** A weld failure was discovered on a critical section of the elevator control system during routine inspection. The issue was traced to an incomplete weld introduced during the initial manufacturing process.

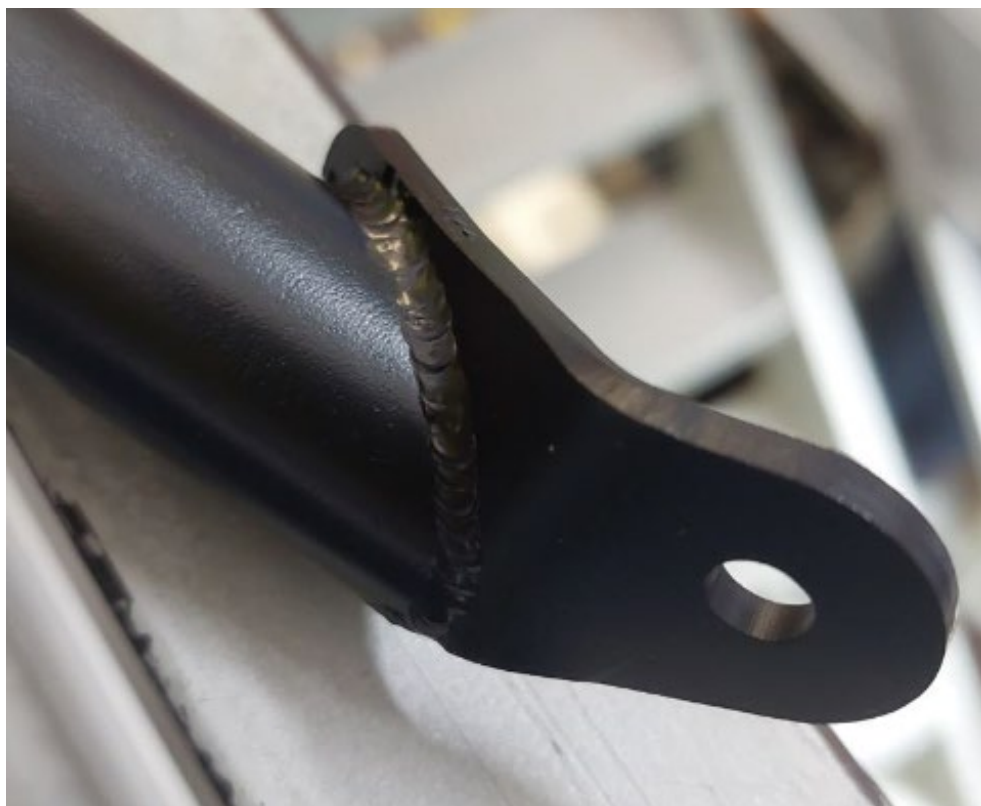
3. Inspect the welding on the control stick rods. If weld is evenly visible all around the joint as shown on Figure 002, the inspection is considered a **pass**. Continue with step 5 of this document.

Figure 002
Example of **correct** welding on the control stick connection rod

5. If inspection of control stick connection rod passed, reinstall control stick boot IAW applicable maintenance manual.
6. Record completion of this service bulletin in aircraft maintenance records.

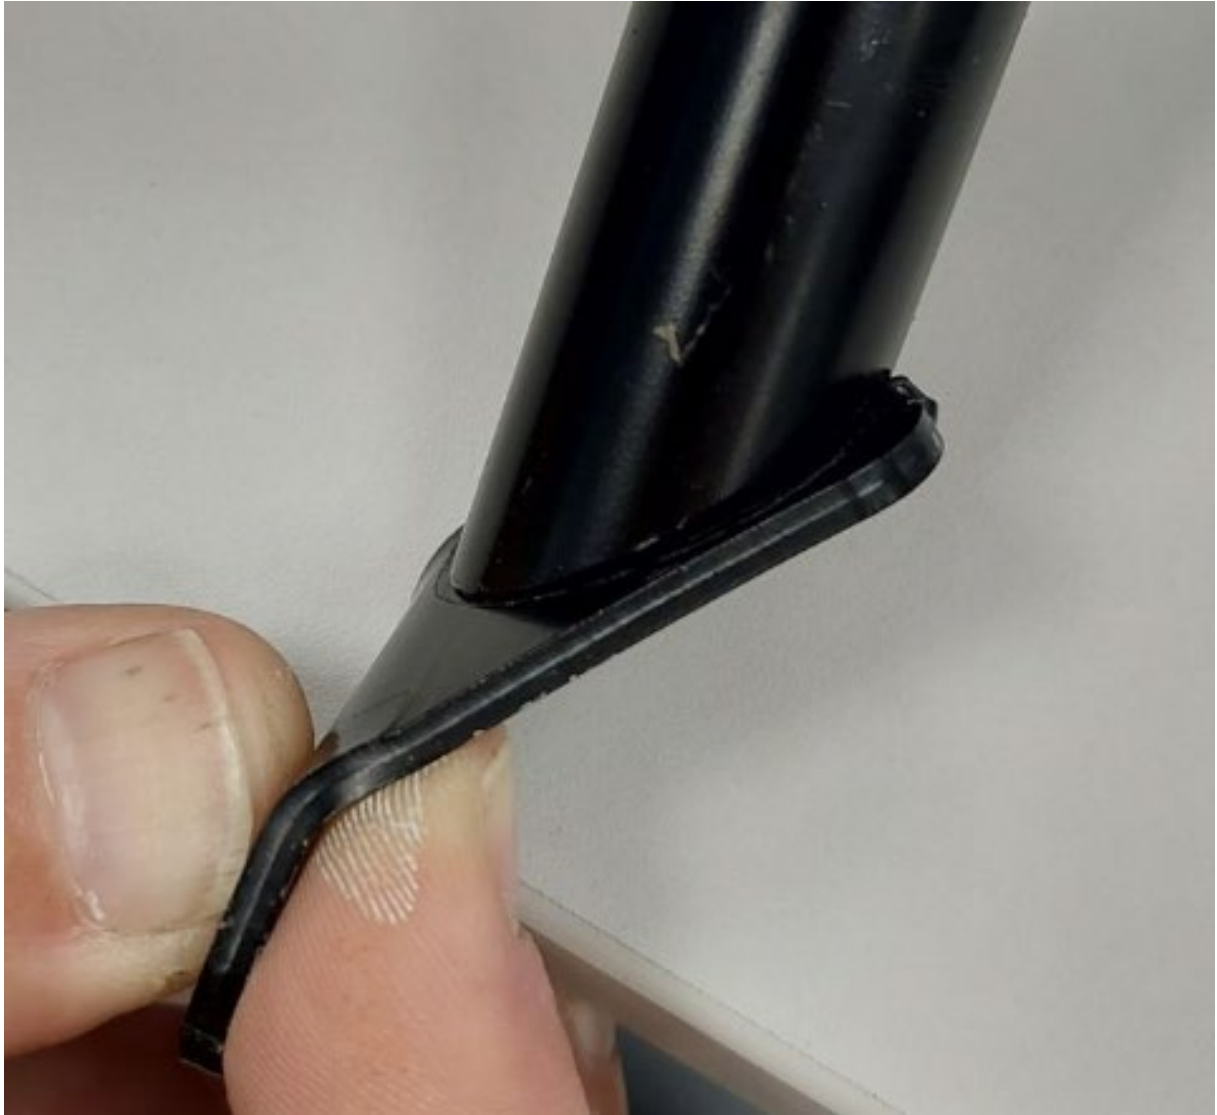
4. If weld is not evenly around the control stick rod or only spot welds are visible, as shown on Figure 003, the inspection has **failed. Suspended flight operations immediately**. Contact Pipistrel Support for further repair of affected component.

Figure 003
Example of **incorrect** weld on the control stick connection rod
