ELA AVIACIÓN, S.L.
SERVICE BULLETIN Nº 16.

Maintenance procedure and lifetime of hub bar P/Nº: 14-145B

Date of issue: 8th September 2012.

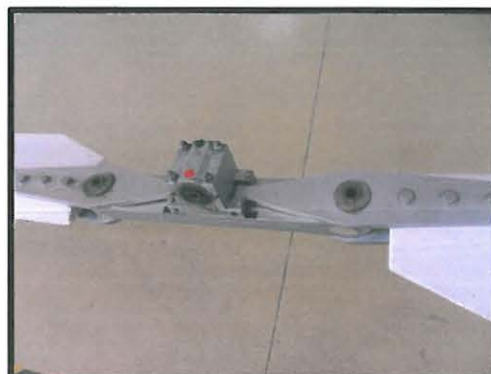
- 1) Remove the rotor from the gyroplane and put it over trestles.

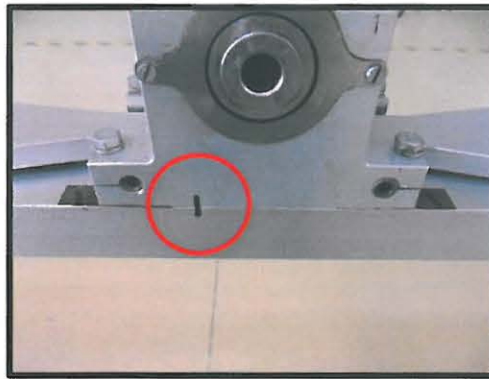
2) Mark the position of the hub block with the hub bar and remove it. It is not necessary to remove the blades from the hub bar.

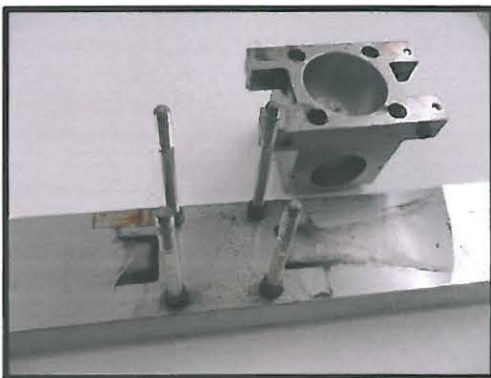
3) Clean the parts and inspect the bore holes to confirm the absence of cracks in the hub bar and block. Perform a dye penetrant inspection test on this area of the hub bar by a qualified inspector.

4) Re-assemble the block with new bolts and nuts in the same position.

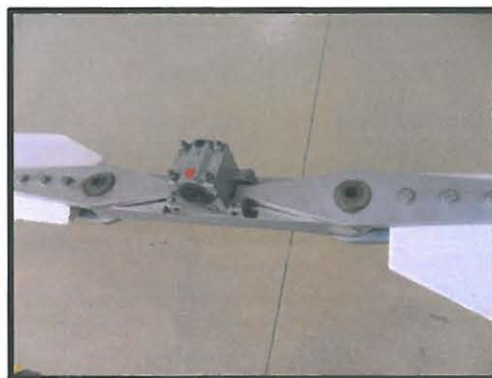
- 1) Remove the rotor from the gyroplane and put it over trestles.

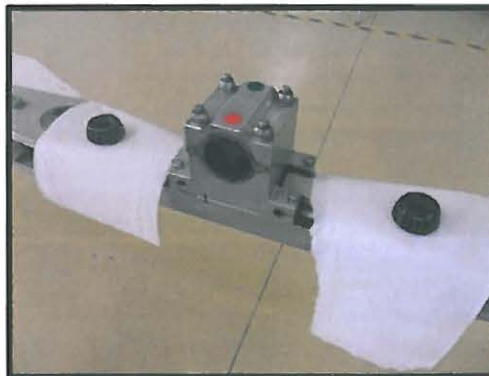
- 2) Remove the hub bar bearings for replacing.

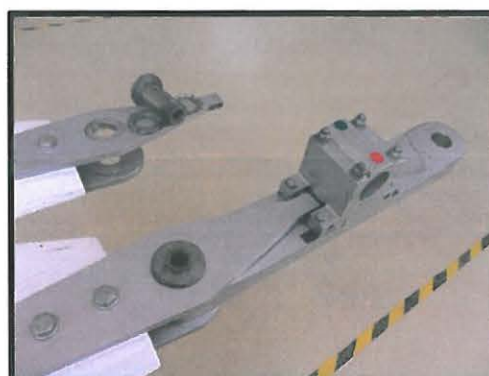
- 3) Remove the rotor blades from the hub bar.

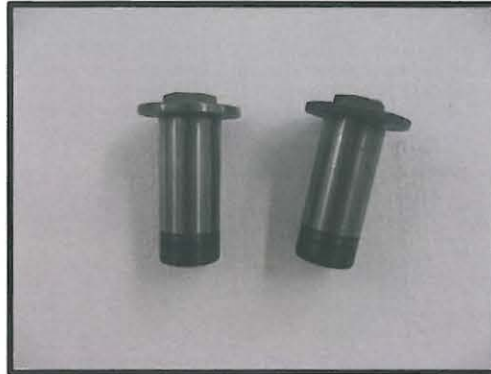
- 4) Clean the bolts of the rotor blades and grease them with spray.

- 5) Disassembly the hub block from the hub bar, clean and install it in the new one with new AN-5 bolts and nuts. Tightening torque: 18N/m +/- 1.
- 6) Re-install the rotor blades in the new hub bar. Tightening torque (30mm bolts): 120N/m.
- 7) Re- install the rotor on the gyroplane.
