**Company name:** Pipistrel Vertical Solutions d.o.o.

**Type:** Taurus

**SB name: Airbrakes Bellcrank Inspection****Category:** Information / Recommended / ~~Alert-SB~~ / Mandatory**Subject:** Airbrake bellcrank inspection.

**Reason:** Pipistrel was informed about an in-service occurrence of the airbrake bellcrank failure that resulted in an un-commanded airbrake deployment.

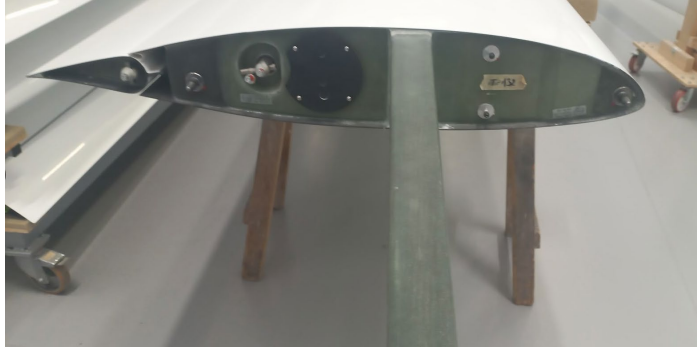
Figure 1 - Wing removed from aircraft

1. Remove wings iaw. 57-10: 2.1.1. in [1].
2. Place the wings on trestles.

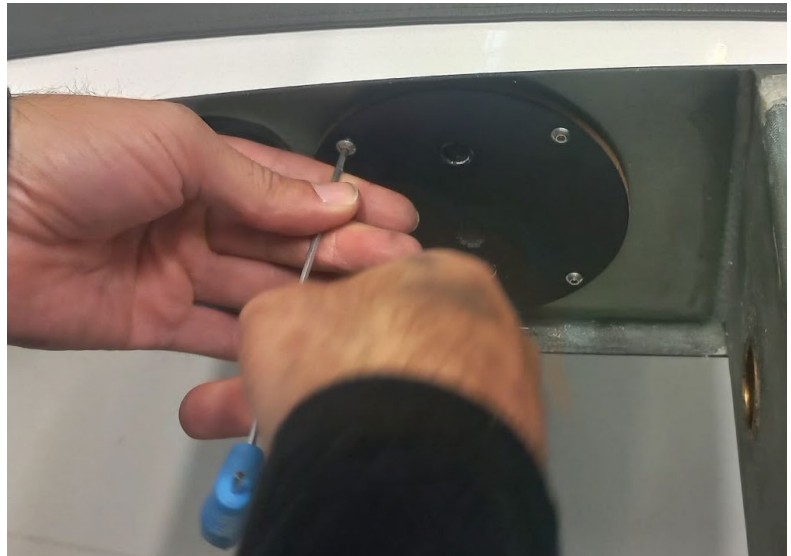
Figure 2 - Opening inspection hole

3. Locate the covered inspection hole AFT of the main spar.
4. Unscrew the cover of the inspection hole AFT of the main spar using 3 mm Allen key.

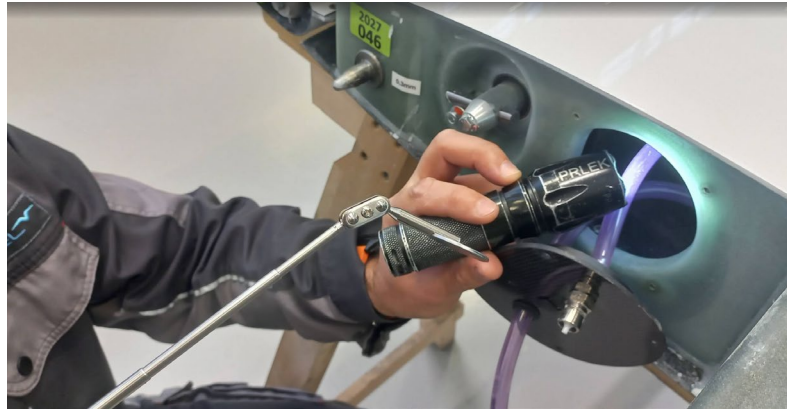
Figure 3 - Inspection through the opening

6. When opened, use a flashlight and a mirror (or borescope) to inspect the weld seams of airbrake bellcrank. See next step, instructing the inspection and evaluation of findings.

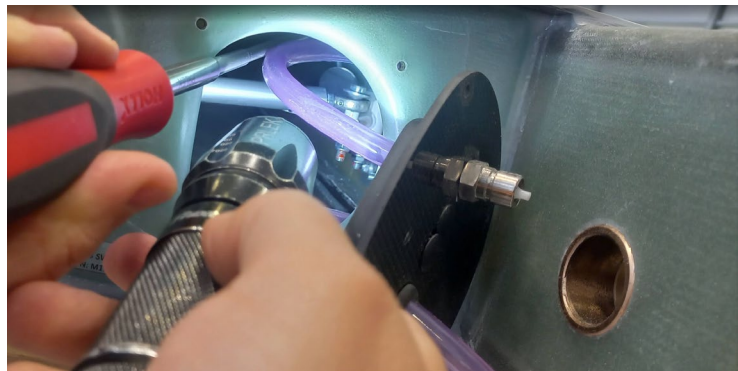
Figure 4 - Closeup of the inspection

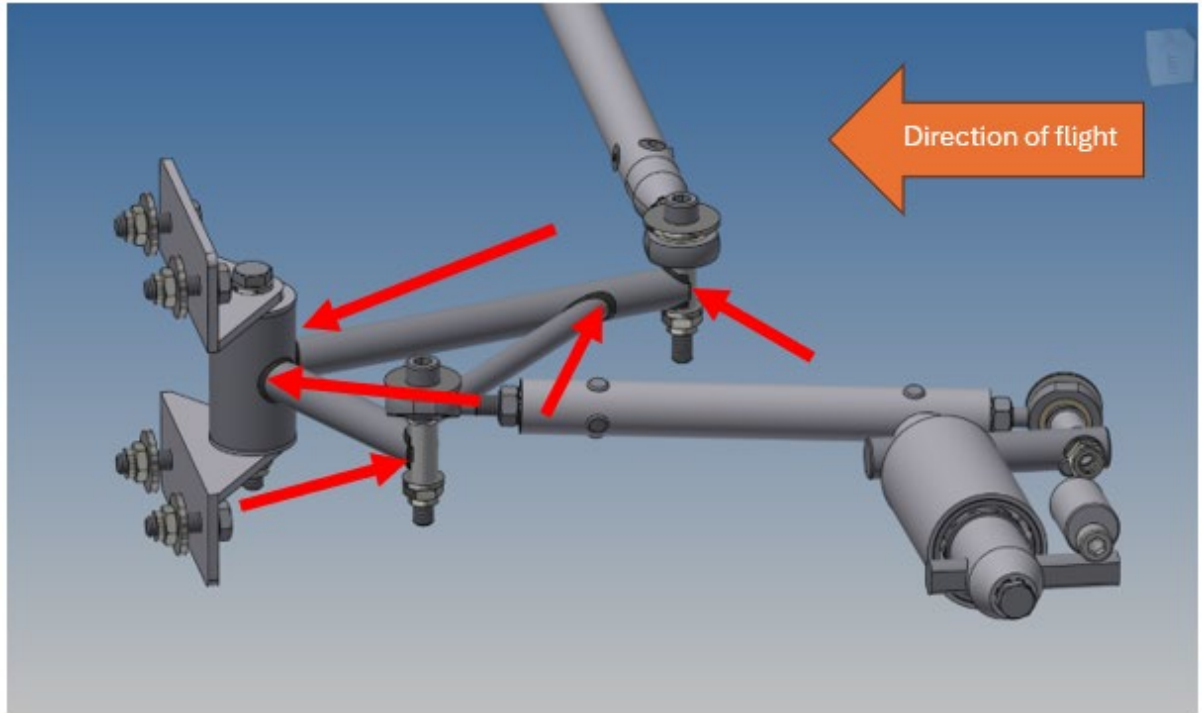
Figure 5 – Identification of weld seams that are subject to inspection

**NOTE:** The 3D model above shows the bellcrank mechanism installed on an RH wing. The view is positioned to show the perspective as the wing is upright on the trestles, the leading edge faces towards the left side of the figure. See red arrows marking all the weld seams that are subject to inspection.

- 7.1. Check the weld seams on each airbrake bellcrank (P/N 1181065) as identified in Figure below (see red markings):

**CAUTION:** Examine the entire circumference of the tubes, make sure all edges are inspected.

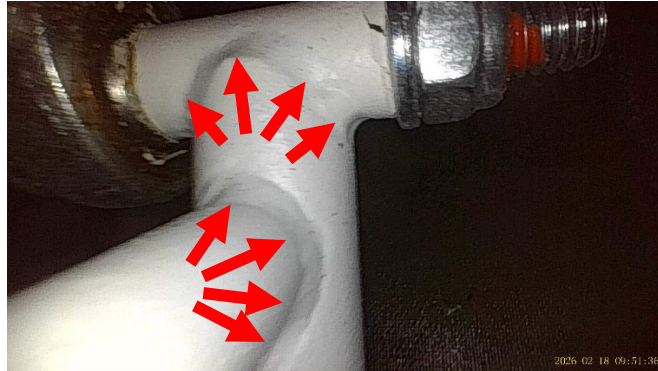
Figure 6 - Weld seams are applied **continuously** around the **entire circumference** of all tube contact points.

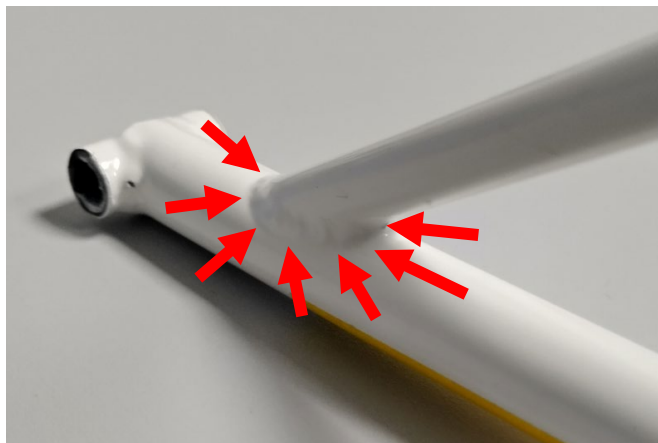
Figure 7 - Weld seams are applied **continuously** around the **entire circumference** of all tube contact points.

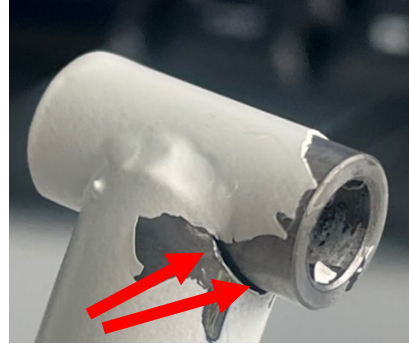
Figure 8 - Weld seams **don't cover the entire circumference** of the tube, red arrows pointing at the missing weld seams - example with paint partly removed.

If any findings are identified, promptly contact Pipistrel Support through the online [Product Support form](#) with photos attached and proceed with Procedure Part B as outlined below to ensure the continued airworthiness of the subject aircraft. If findings are identified during inspection, aircraft cannot be dispatched until bellcrank replacement is performed according to Part B.

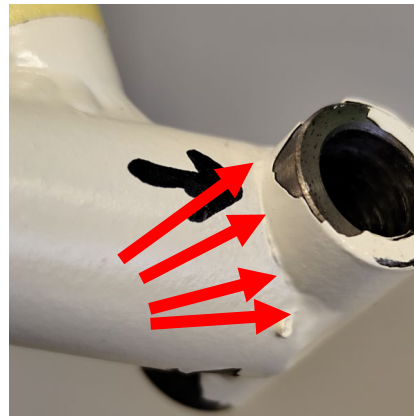
Figure 9 - Weld seams **don't cover the entire circumference** of the tube, red arrows pointing at the missing weld seams - example with paint present.

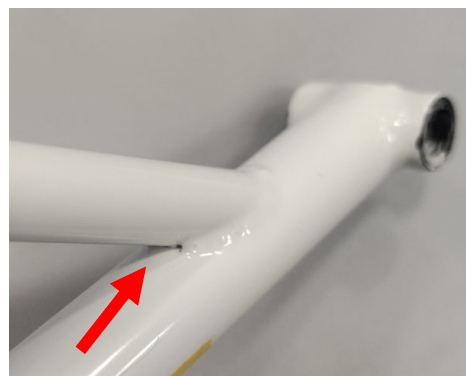
Figure 10 - Another instance of a **missing weld seam at the tube corner contact point**.

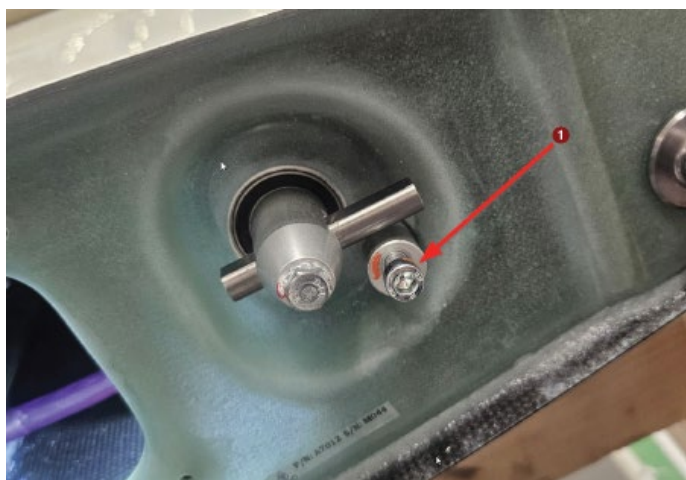
Figure 11 - Airbrake limiter

1. Remove air brake limiter bolt (index 1 on Fig. 6).

11. Apply Loctite 243 to thread and reinstall air brake limiter bolt (see Figure 11).
12. Remove foam padding and lower air brake.
13. Repeat steps 1-12 on the other wing.
14. Perform air brake inspection iaw. 57-70: 2.1.1. in [1].
15. Perform air brake extension adjustment iaw. 57-70: 2.2.1. in [1].
16. Perform closing moment check with the airbrake torque check attachment iaw. 57-70: 2.2.2. in [1].
17. Reinstall wings iaw. 57-10: 2.1.2. in [1].
18. Fill out aircraft logs.

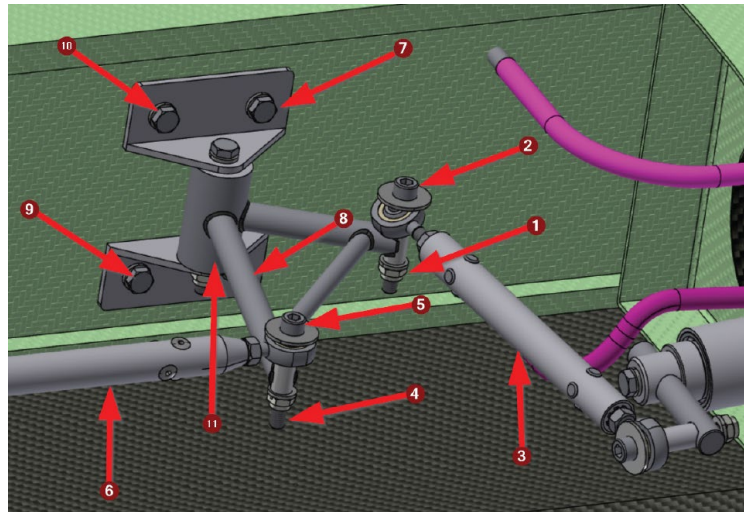
Figure 12 - Airbrake bellcrank assembly

3. Remove and discard nut (index 1 on Figure 12), remove washers and bolt (index 2 on Figure 12) and disconnect short air brake drive push rod (index 3 on Figure 12).

4. Remove and discard nut (index 4 on Figure 12), remove washers and bolt (index 5 on Figure 12) and disconnect long air brake drive push rod (index 6 on Figure 12).
5. Remove bolts (index 7,8,9,10 on Figure 12) and washers securing bell crank assembly (index 11 on Figure 12) on to wing. Discard nuts.

8. Apply Loctite 243 on threads and install bolts, washers and new self-locking nuts (index 7,8,9 and 10 on Figure 12). Tighten nuts (4 EA) in a cross pattern to 9 Nm. Mark heads/threads with torque stripe.
9. Connect long air brake drive push rod (index 6 on Figure 12) to bell crank. Install bolt (index 5 on Figure 12), washers, apply Loctite 243 to threads and install new nut (index 4 on Figure 12). Tighten nut to 9 Nm. Mark connection with torque stripe.
10. Connect short airbrake drive push rod (index 3 on Figure 12) to bell crank assembly. Install washers, bolt (index 2 on Figure 12), apply Loctite 243 to threads and install new nut (index 1 on Figure 12). Tighten nut to 9 Nm. Mark connection with torque stripe.

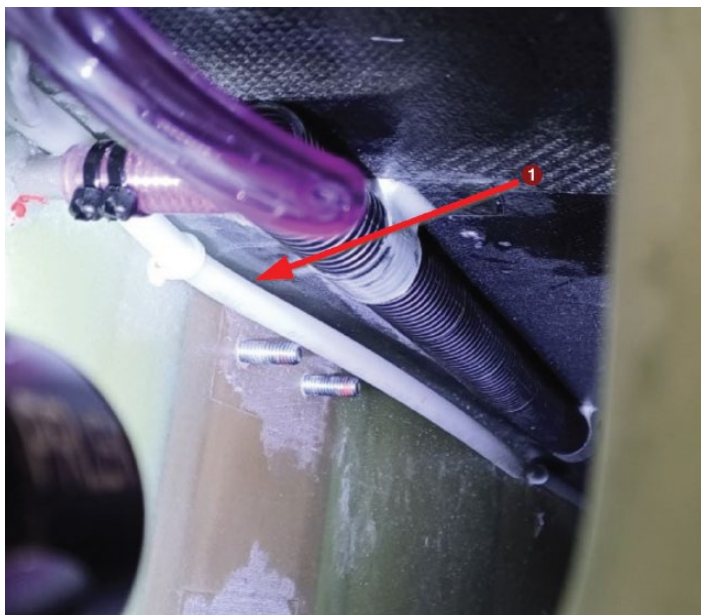
Figure 13 - Wingtip light wiring tube

6. Carefully push wiring tube (if installed) of wingtip lights away (index 1 on Figure 13) and remove bell crank assembly from wing.
