Lufttüchtigkeitsanweisung
LTA-Nr.: DULV-2014-001
Datum der Bekanntgabe: 13.06.2014

Luftsportgeräte-Muster:
ELA 07 Cougar; ELA 07 S

ELA AVIACIÓN, S.L.
SERVICE BULLETIN Nº 16.

Maintenance procedure and lifetime of hub bar P/Nº: 14-145B

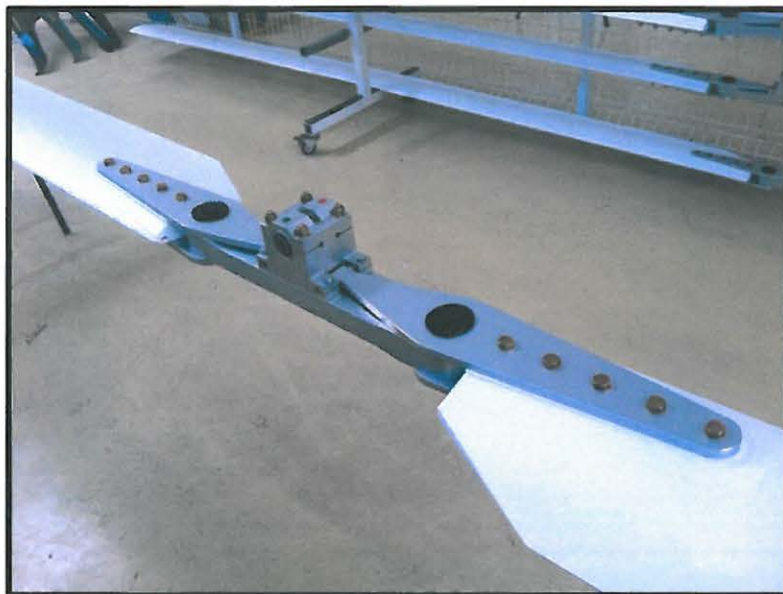
In the case of non-proper use, storage, inspection and maintenance of the gyro, there is an area in the hub bar where some cracks can appear during operation.

This area is located in the lower face of the hub bar, where the bolts heads are inserted in a machined groove.

Non-compliance with this service bulletin may cause the total collapse of the rotor in flight and therefore the loss of life of the pilots
